# State of Utah DEPARTMENT OF NATURAL RESOURCES Division of Oil, Gas & Mining

## Inspection Report Minerals Regulatory Program April 11, 2012

Mine Name: Levan Henry	Permit Number: M/023/0023		
Operator Name: Sunroc	Inspection Date: 3/29/2012		
Inspector(s): Wayne Western	Time: 12:50-1:20 pm		
Other Participants: none	Mine Status: ACT		
Weather Condition: cool and clear skies	Last Inspection: 07/13/2010		
Bond Renewal Date: May 8, 2012	Bond Amount: \$99,735		
Surface Ownership: USFS/FEE	Mineral Ownership: Fee

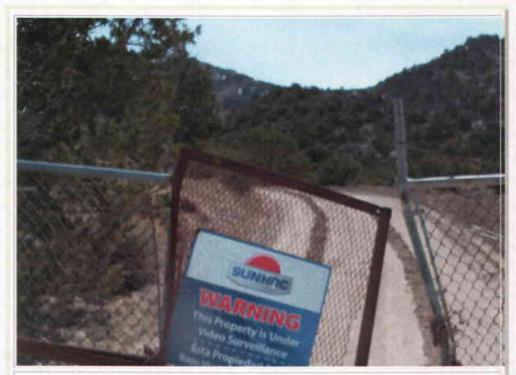
Access to the site is through a locked gate. There were fire pits and alcohol bottles on site which suggests partiers could be visiting the site.

Entrance to mine site

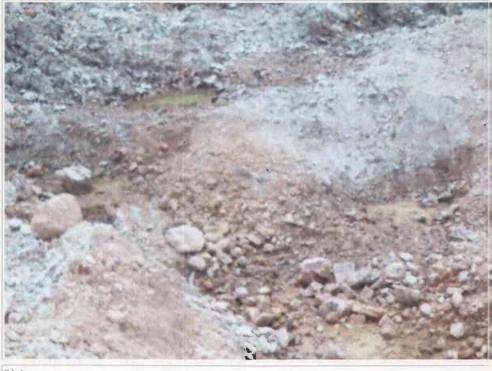
Pit bottom

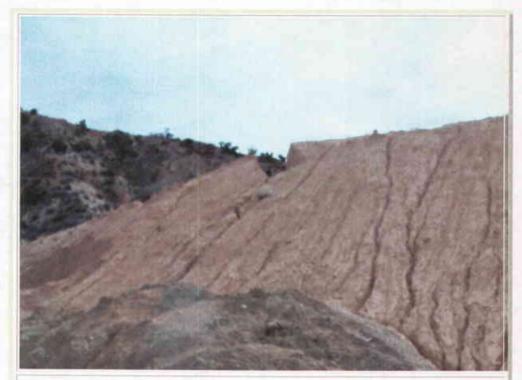
Rilles and gullies on outslope

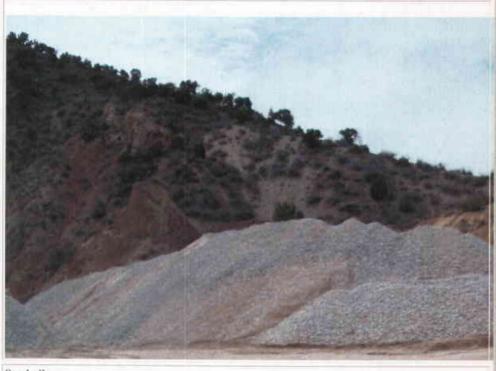
Stockpile
